Audit, Standards and Risk Committee Update on Bernard Road

VERSION 1.0 DATE 12/05/2023

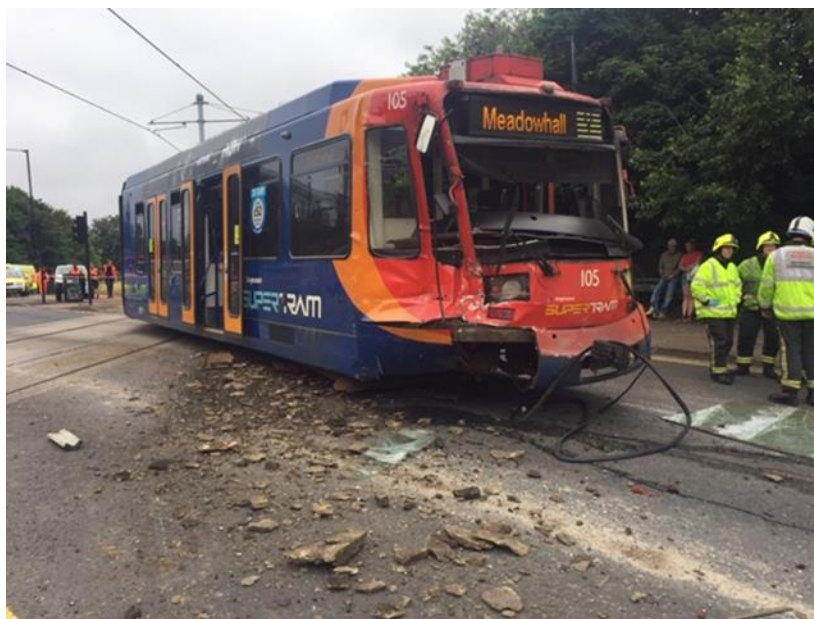
Board members will recall a serious collision occurred at the Bernard Road junction with Cricket Inn Road (adjacent to the Hyde Park tram stop) on 23 July 2021.

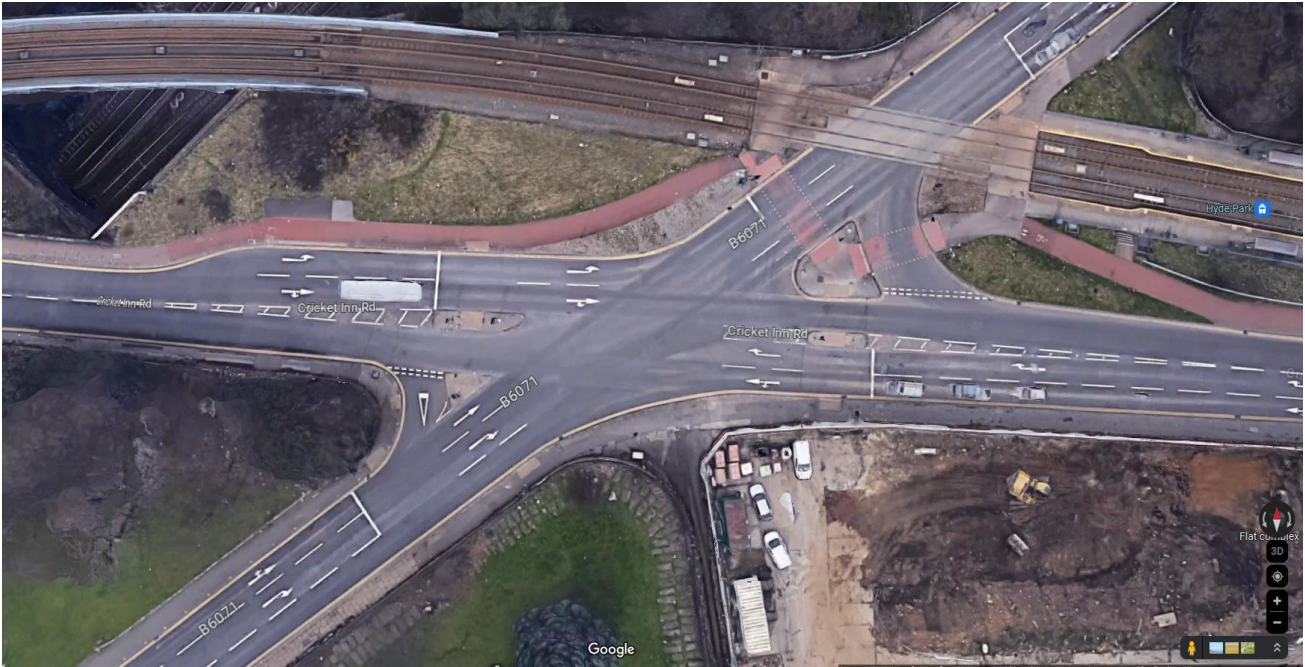
Currently north-east bound traffic on Bernard Street (B6071 on the site image below) can either use the nearside lane to turn left into Cricket Inn Road or go 'straight ahead' (crossing the tram tracks), or alternatively use the offside lane to turn right onto Cricket Inn Road. The traffic signals work so that the two traffic lanes can receive a green signal independently of one another or both lanes can receive a green signal at the same time.

The reported concern is that traffic coming from Bernard Street to Bernard Road (the straight-ahead movement) is either ignoring or is for other reasons proceeding when the nearside lane is on a red signal phase. It has been identified that in order to reduce the potential for confusion, or misreading of the signals, for traffic headed straight ahead that the offside lane should not run a green phase independently of the nearside lane. This will potentially reduce occasions where drivers not paying full attention may see traffic setting off from the offside lane and proceed even though the nearside lane is on a red light.

This is particularly important in reducing potential tram conflict given that the offside lane 'right turning' traffic from Bernard Street is only given a green light independently of the nearside lane when the tram is crossing Bernard Road. So, should someone heading from Bernard Street to Bernard Road misread the signals they are more likely to come into potential conflict with a tram. However, it should be noted that in order to do this they would also have to proceed through a further red light and stop line in advance of the tram tracks as people enter Bernard Road (this can be seen right centre on the site image above).

This change means that neither lane on Bernard Street progressing north-east will be given a green light when the tram is crossing Bernard Road.
